RISK WATCH

ECDIS

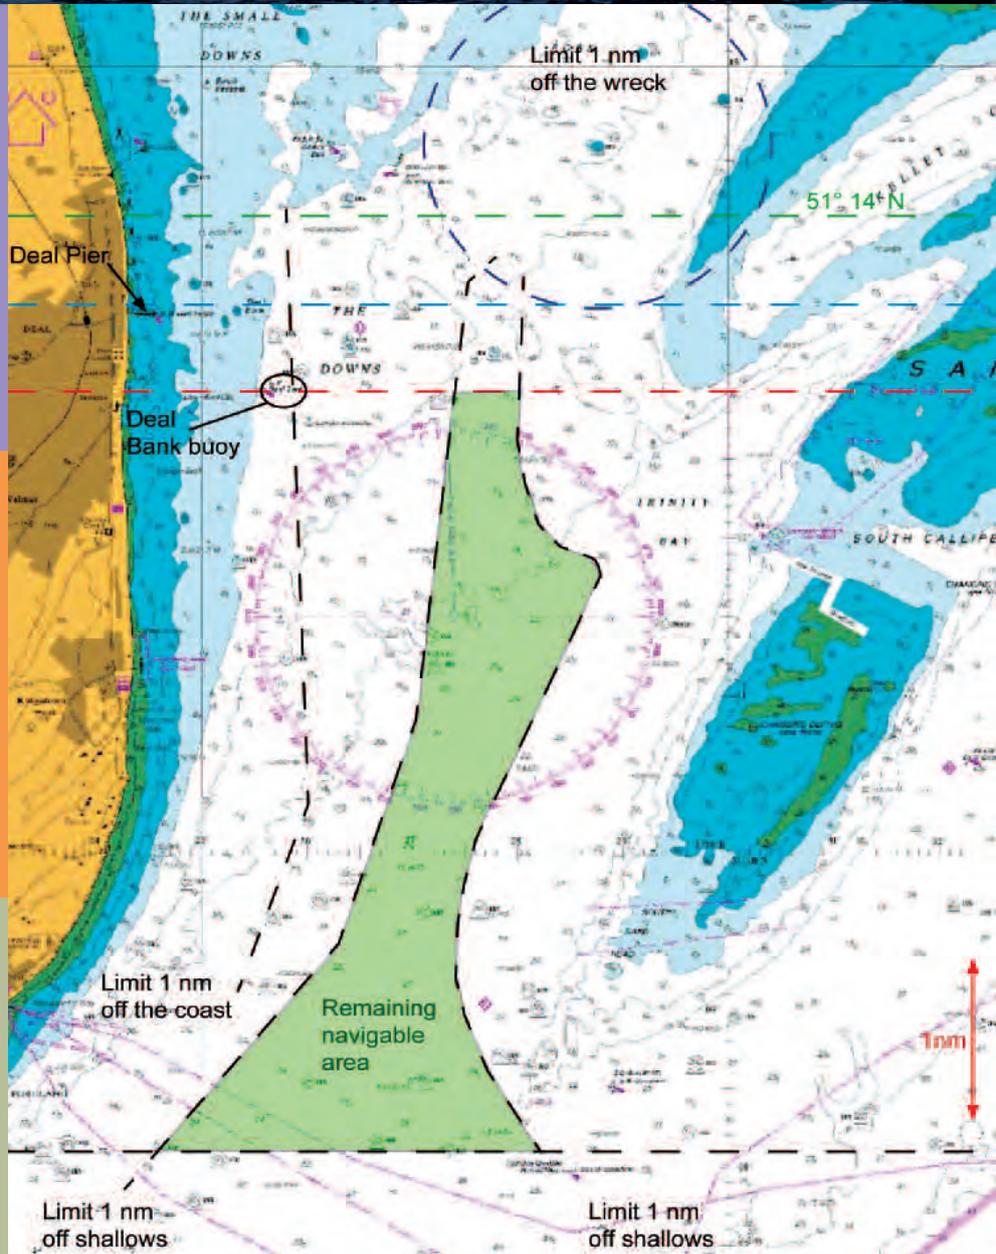
■ Navigable area taking account of Master's restrictions
— Northern limit on the 2nd run
- - Northern limit on the final run
— Northern limit on the 1st run

The Managers had a policy of not relying entirely on the ECDIS hence there were relevant paper charts on the chart table. Notwithstanding this, navigation was being carried out almost exclusively by reference to the ECDIS, even though the system was 'non-approved'. Illustrating this was the fact that the Master's parameters for navigation limits whilst slow-steaming had not been drawn on the paper chart.

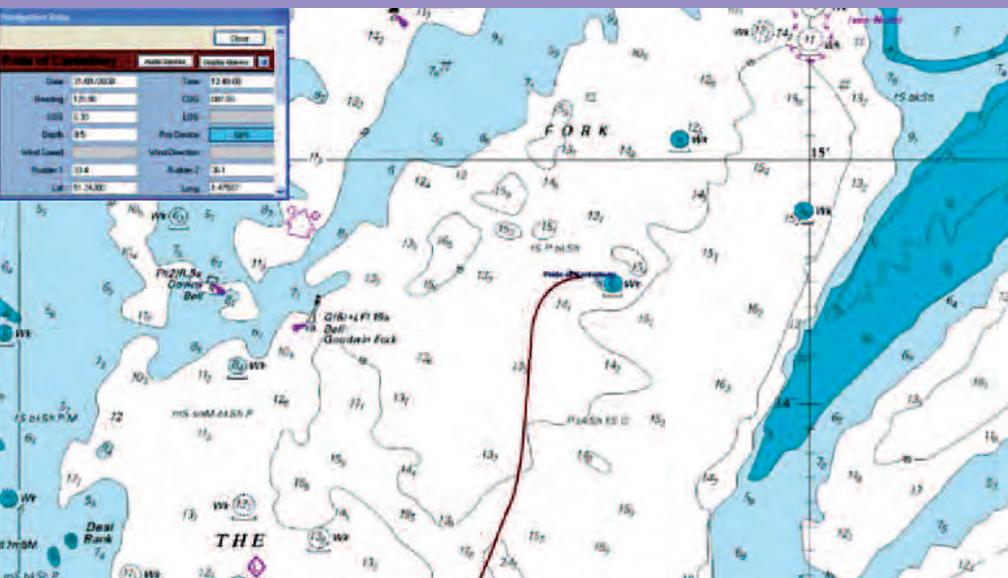
Track record of PRIDE OF CANTERBURY approaching the wreck of MAHRATTA.

The UK Maritime Accident Investigation Branch official report concerning a large passenger ferry (PRIDE OF CANTERBURY) which grounded on a charted wreck detailed that the ECS (Electronic Chart System) was not approved for use as the primary means of navigation, although the officers were utilising it as if it was. In addition, none of the bridge team who were on watch during the period in which the vessel was navigating in close proximity to land had undergone any generic training in the use of ECDIS. Indeed only the vessel's Master had attended the manufacturer's own in-house course for training in the use of such equipment. It is believed that the lack of proper training in the use of ECDIS possibly led to the

The chief officer ordered hard to starboard; soon after, the Master noted a shallow patch on the ECDIS and full ahead on the port engine was ordered. The chief officer suggested going astern but the Master dismissed the advice. As the turn continued the ECDIS showed that the bow had swung clear of the shallow patch but a load noise was then heard. The vessel had suffered serious damage to her port propeller.

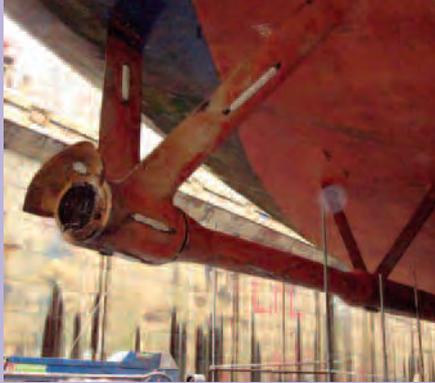
Port side missing CP propeller and hub.

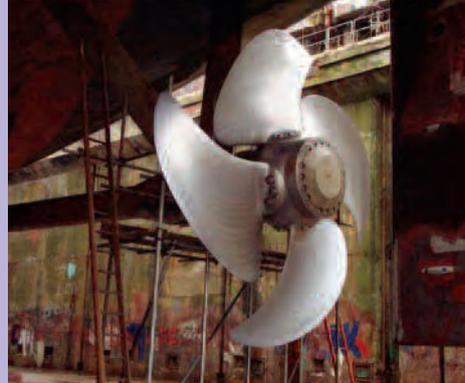
Starboard CP propeller and hub.

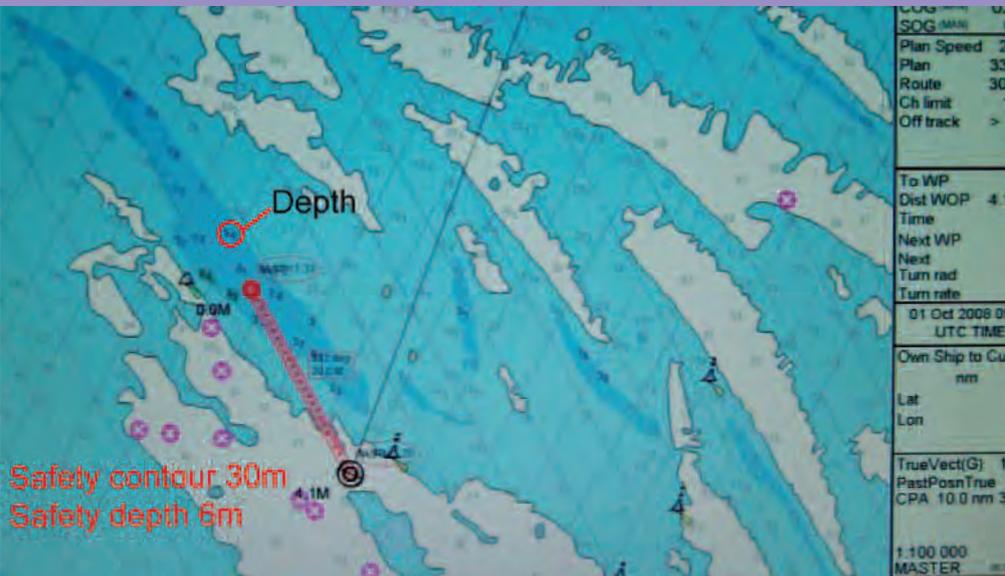
Screen shot of ECDIS display showing depth and contour settings.

Where 'predicted movement' is concerned, the automatic sounding of an audible alarm will occur when the system detects that the vessel is going to cross the safety contour set on the ECDIS display. In order for this alarm function to be activated it is first necessary to ensure that a watch vector has been defined by the operator. The watch vector is generally considered to be an extremely important feature within ECDIS and if it has not been activated then many of the associated electronic chart alarms will not be active. In the grounding incident involving CFL PERFORMER it transpired that the safety contour alarm had been set at 30 metres but the alarm did not sound owing to the fact that the watch vector had not been set. None of the officers onboard were aware of the significance of the safety contour and did not know how to establish a watch vector ahead of the vessel. (The vessel did have an ECDIS manual onboard but it was over 600 pages long).
