RISK WATCH

ECDIS

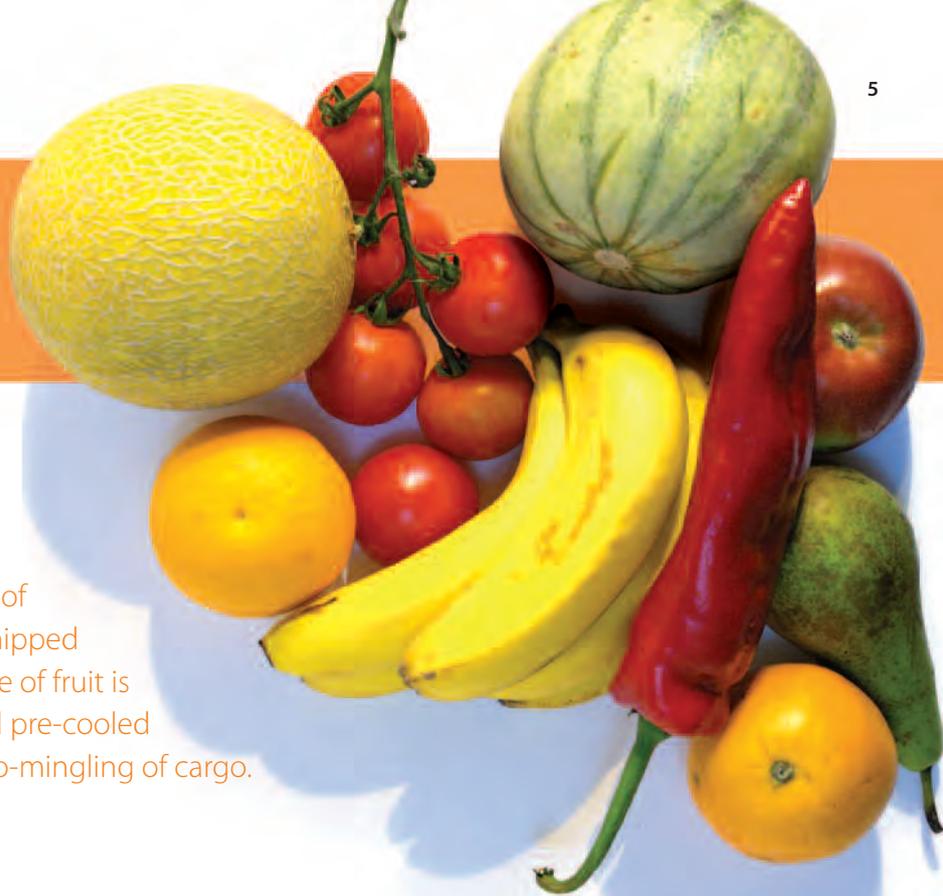
The Association has received notification of problems where two or more fruits are shipped together in the same hold, or a single type of fruit is loaded together in both the ambient and pre-cooled states. This practice is commonly called co-mingling of cargo.

It is generally unwise to allow the co-mingling of fresh fruit in a single hold. Co-mingling implies that all the fruit in that hold will be subject to the same atmospheric conditions. This may not be physiologically acceptable, as fresh fruit can be divided broadly into one of two different types. These are called climacteric fruit and non-climacteric fruit – see list on page 6.

The vessel may not be informed prior to loading that cooled and fresh cargo is to be stowed together. Accordingly regular checks by officers of the pulp temperatures of cargo being loaded is vital and the records of these temperatures must be retained safely. When temperatures are found to be unusually high, all parties must be notified immediately.
